## Gravel Deposits and Flood Risk to Agricultural Land

## Executive Summary

Using three different sites across Scotland, SEPA has investigated the link between sediment deposits in the river channels and flood risk to adjacent agricultural land. The three sites were located on the River Feshie at the confluence with the River Spey, the River Tay near Ballinluig and the River Dee at Ballater.

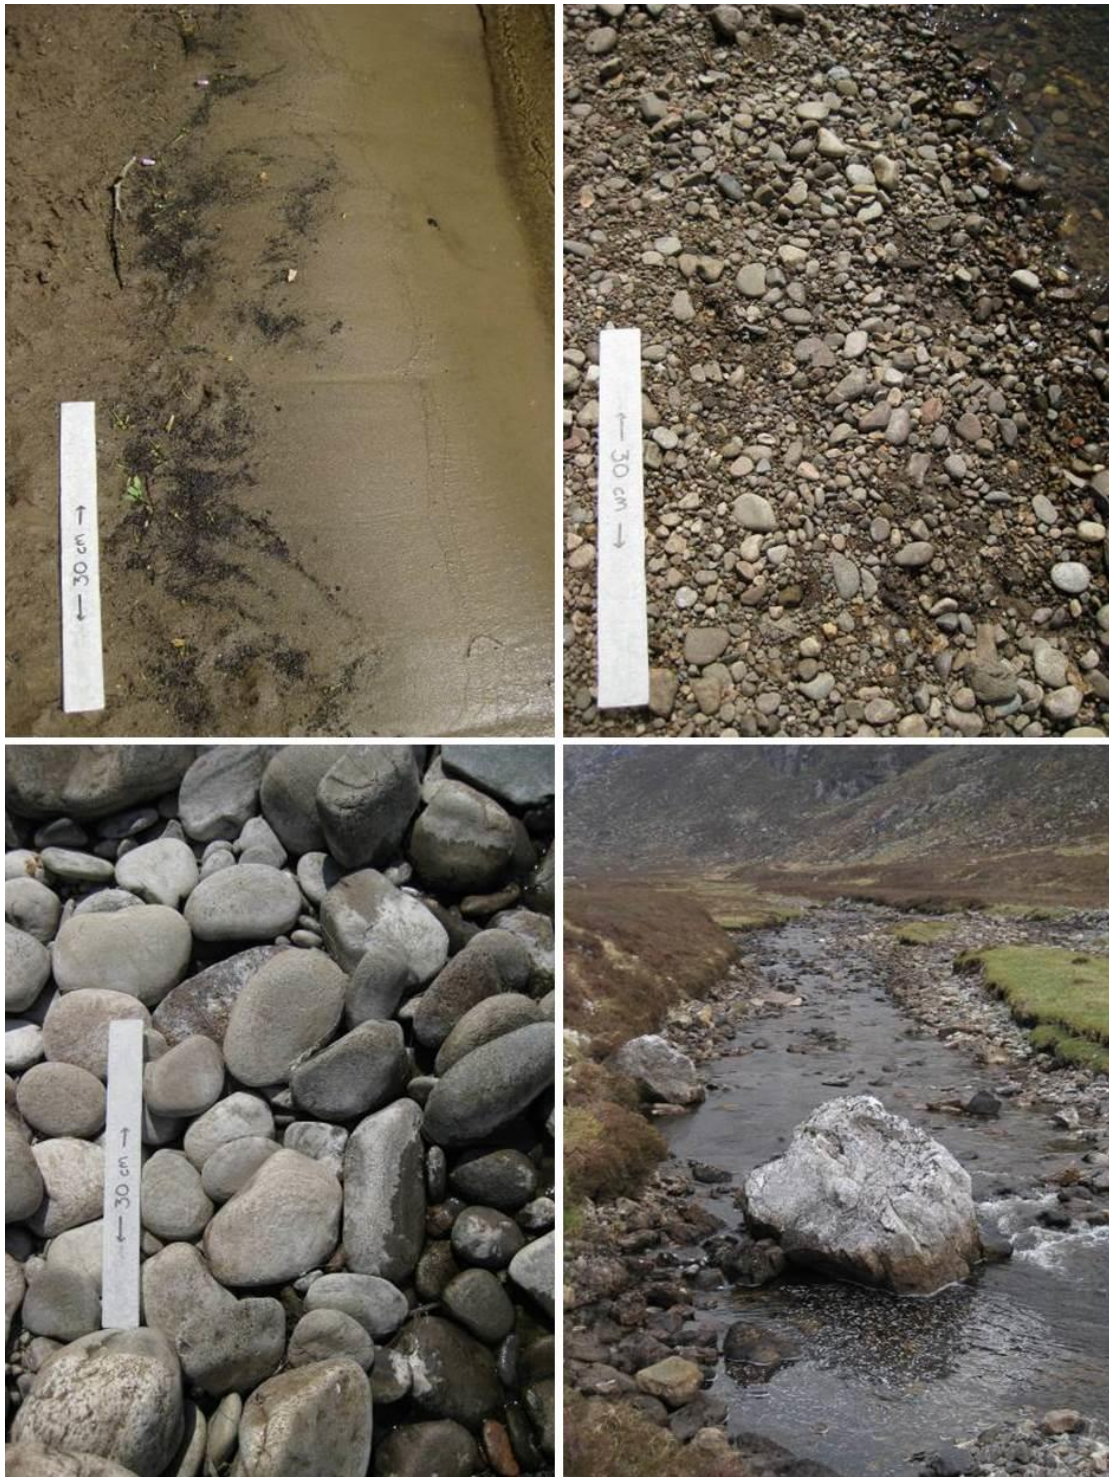
**Figure 1: Examples of river sediment. Top left is clay, silt and sand. Top right is sand and gravel. Bottom left is gravel and cobble. Bottom right is cobble and boulder (including that really big boulder mid picture!).**

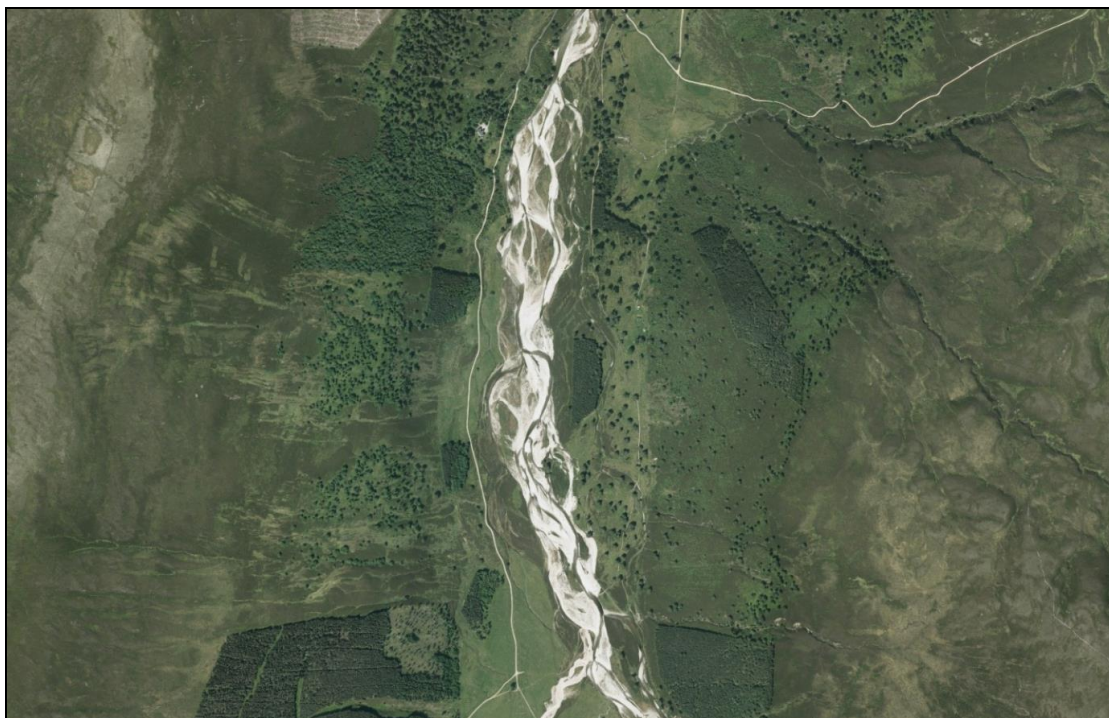
**Figure 6: Aerial image of a typical braided and wandering section of the River Feshie near Glenfeshie Lodge. Note the multiple channels and large areas of exposed sediment in the channel which show that frequent erosion, transport and deposition occurs. The active channel is up to 200m wide in places.**

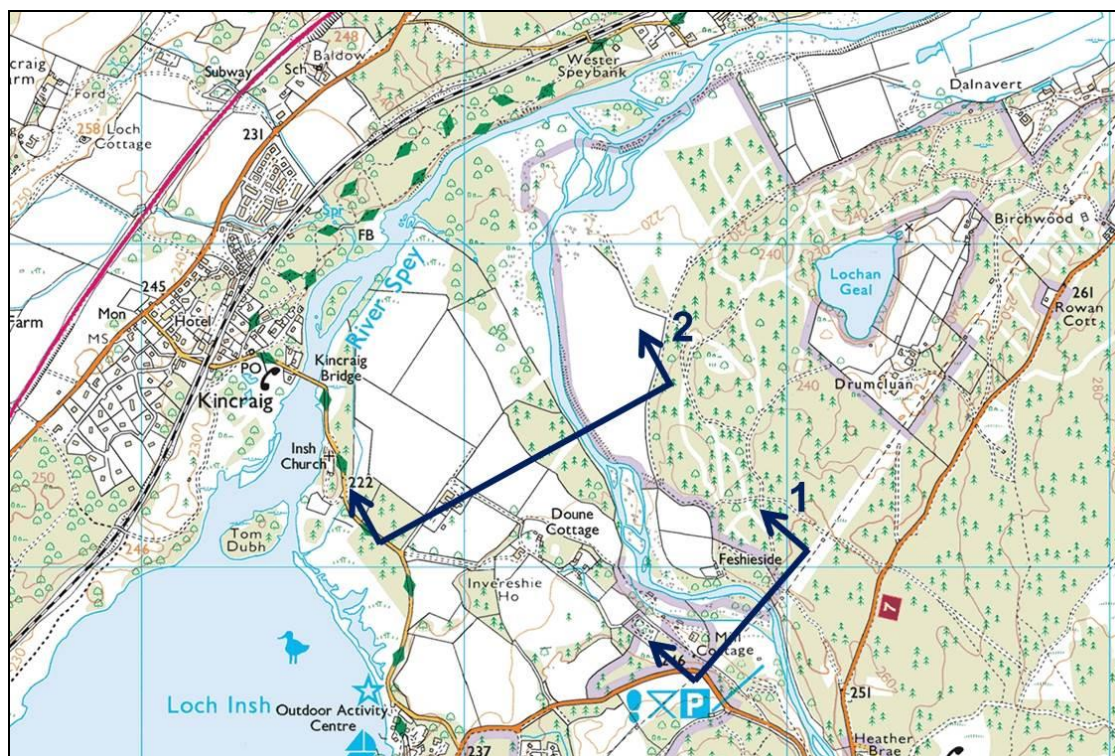
**Figure 15: Plan of reach showing location of cross-sections.**

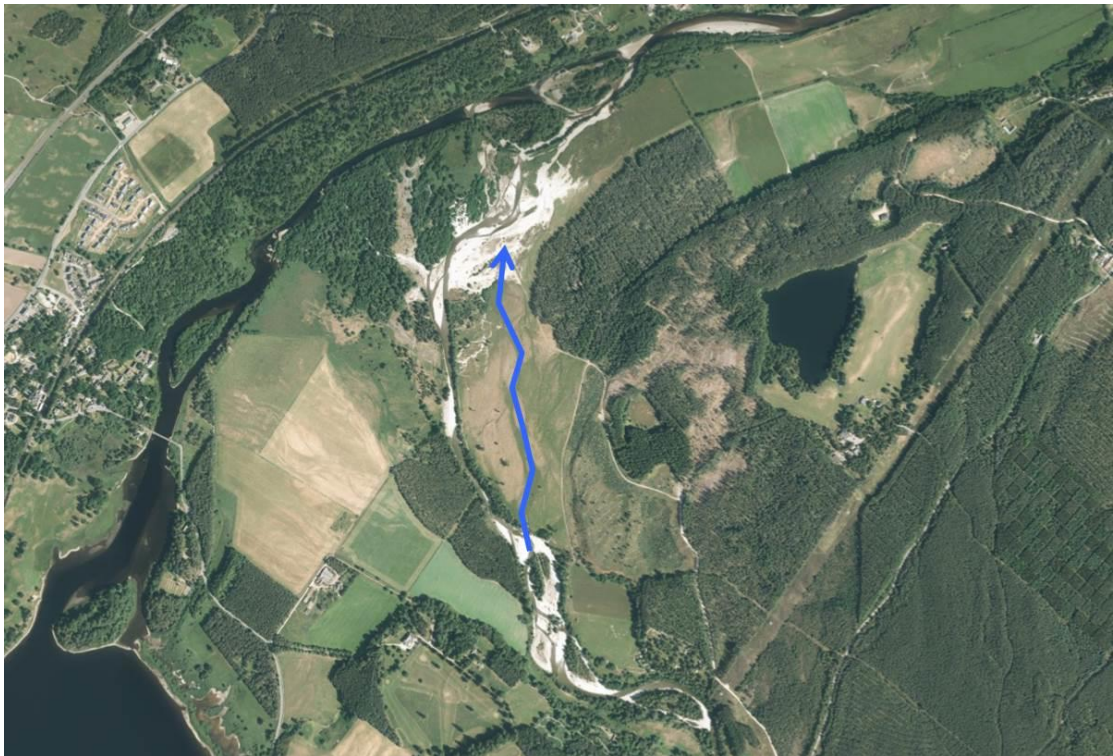
**Figure 21: Aerial image of reach overlaid with option to realign channel to a lower part of the alluvial fan utilizing an old channel. © Getmapping**

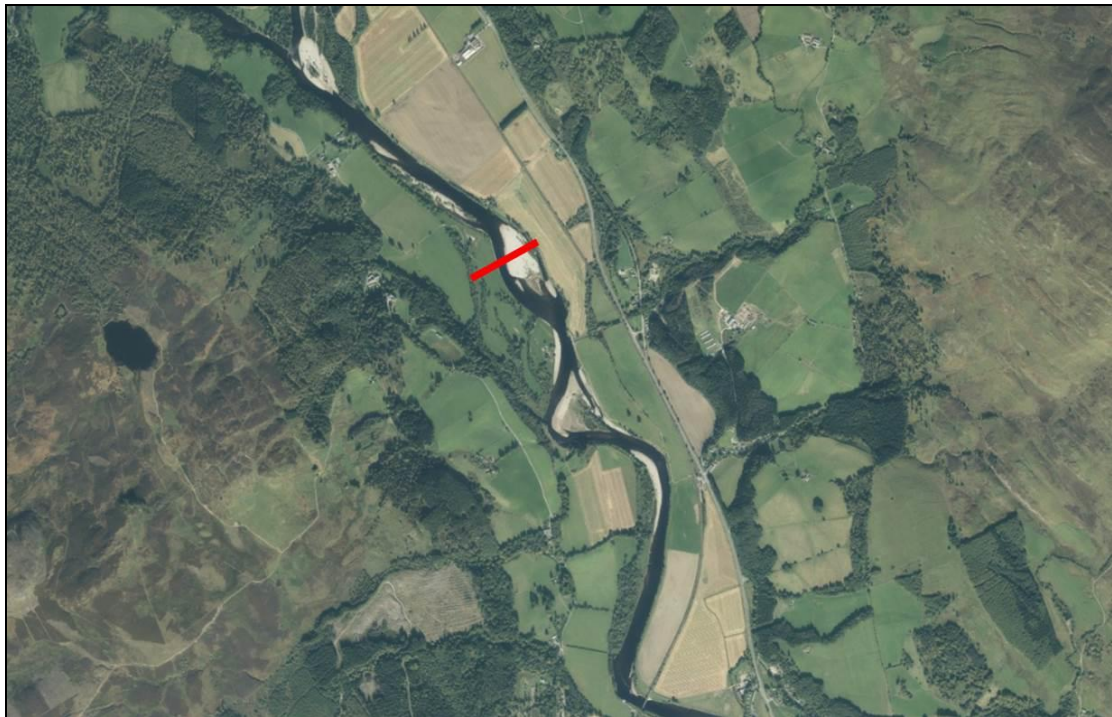
**Figure 36: Aerial image of reach showing location of one of the cross-sections where comparison of 2011 and 2015 surveys was undertaken. © Getmapping**

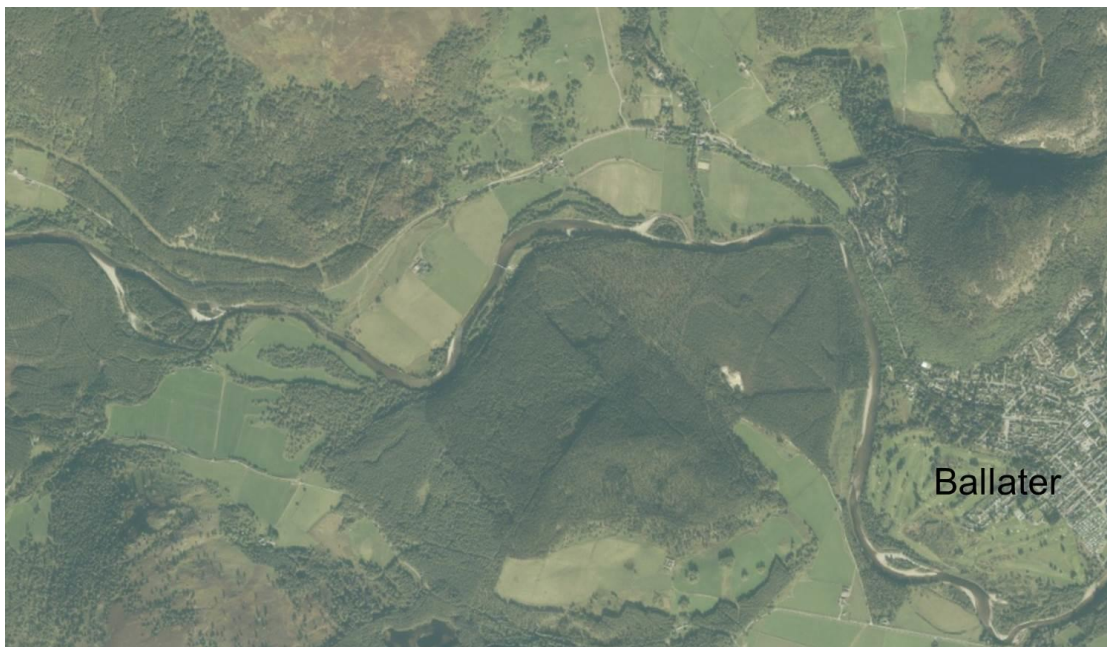
**Figure 46: Recent aerial image of River Dee upstream from Ballater showing increase in sediment deposits in the channel.**

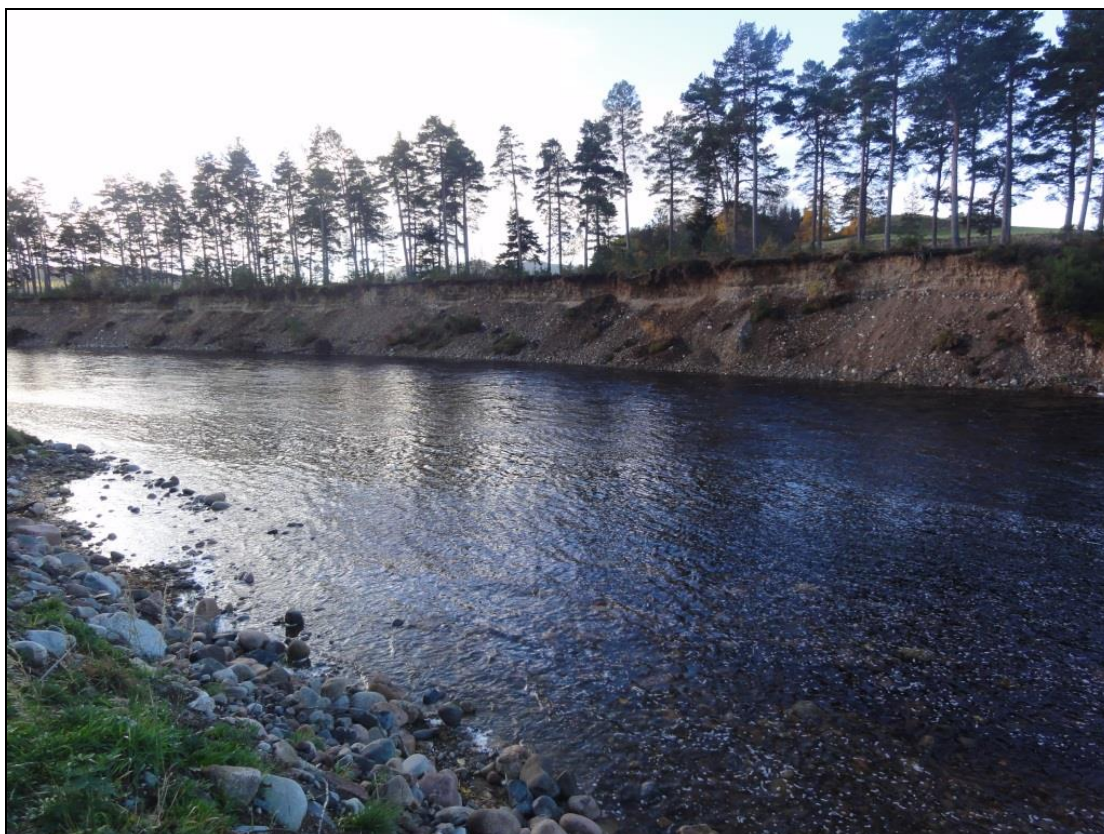
**Figure 52: Severe erosion on the outside bend of the River Dee at Ballater immediately downstream from constriction caused by the embankment.**

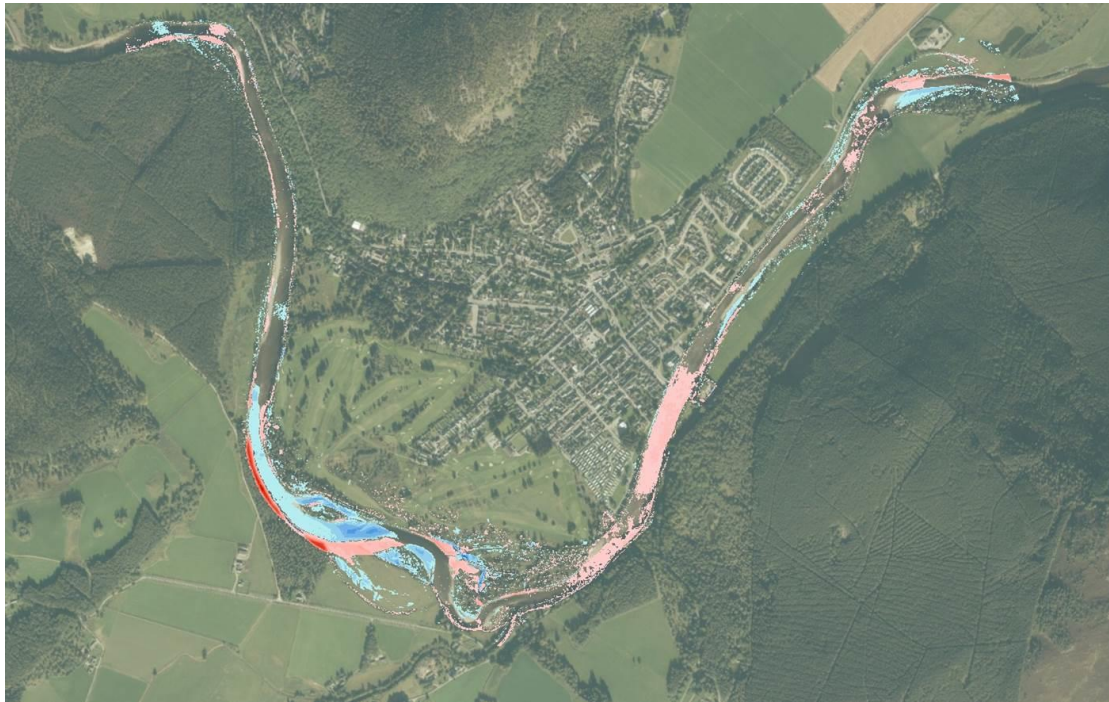
**Figure 53: Aerial image of 5km reach at Ballater overlaid with comparison of LiDAR between 2011 and 2016. Red areas show erosion (land lower in 2016 than 2011) and blue areas show deposition (land higher in 2016 than in 2011). Light colours indicate small changes and dark colours indicate large changes.**

We first compared the surveys over a 5km length of channel around Ballater (Figure 53). We found that there had been roughly 100,000 Tonnes of erosion and 55,000 Tonnes of deposition between 2011 and 2016. This means that there was net

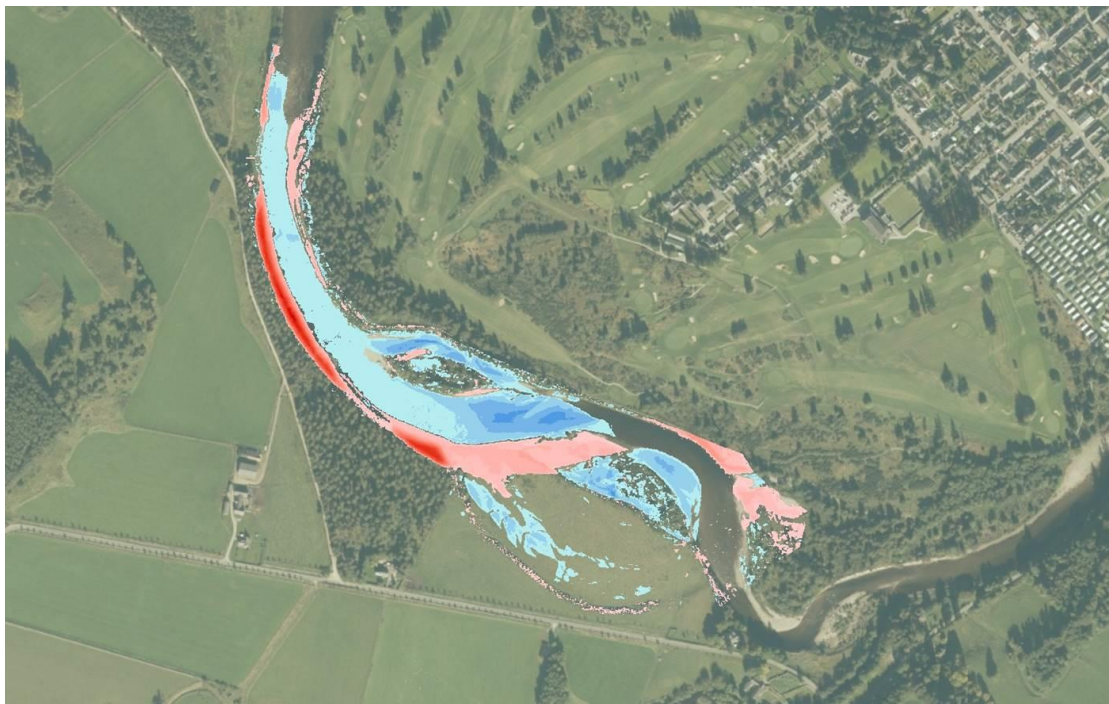
**Figure 54: Aerial image of the “Red Brae” area overlaid with comparison of LiDAR between 2011 and 2016. Colours as per Figure 53. © Getmapping**

We found that in this area there was net overall erosion of about 18,000Tonnes (allowing for water level difference). This is equivalent to about 4 Olympic sized swimming pools worth of sediment. It is interesting that despite the appearance of significant areas of “new” sediment following the floods in Dec 2015 in particular (e.g. **Figure 55**), there has in fact been net erosion. In other words, the large flood events have re-distributed sediment in the channel but overall the channel is now slightly bigger.

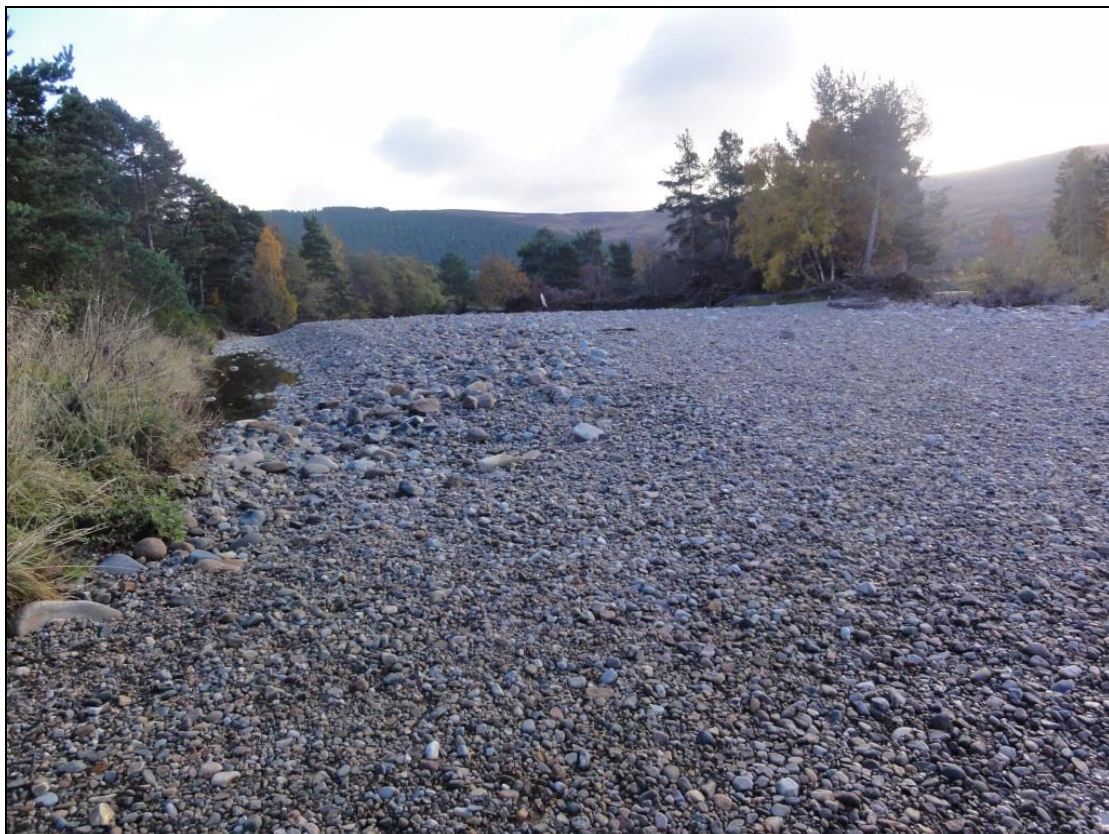
**Figure 55: Significant area of recently deposited sediment in the side channel opposite the Red Brae. Sediment had been removed from this side channel in 1994 following concerns about flooding and erosion of the Red Brae opposite.**

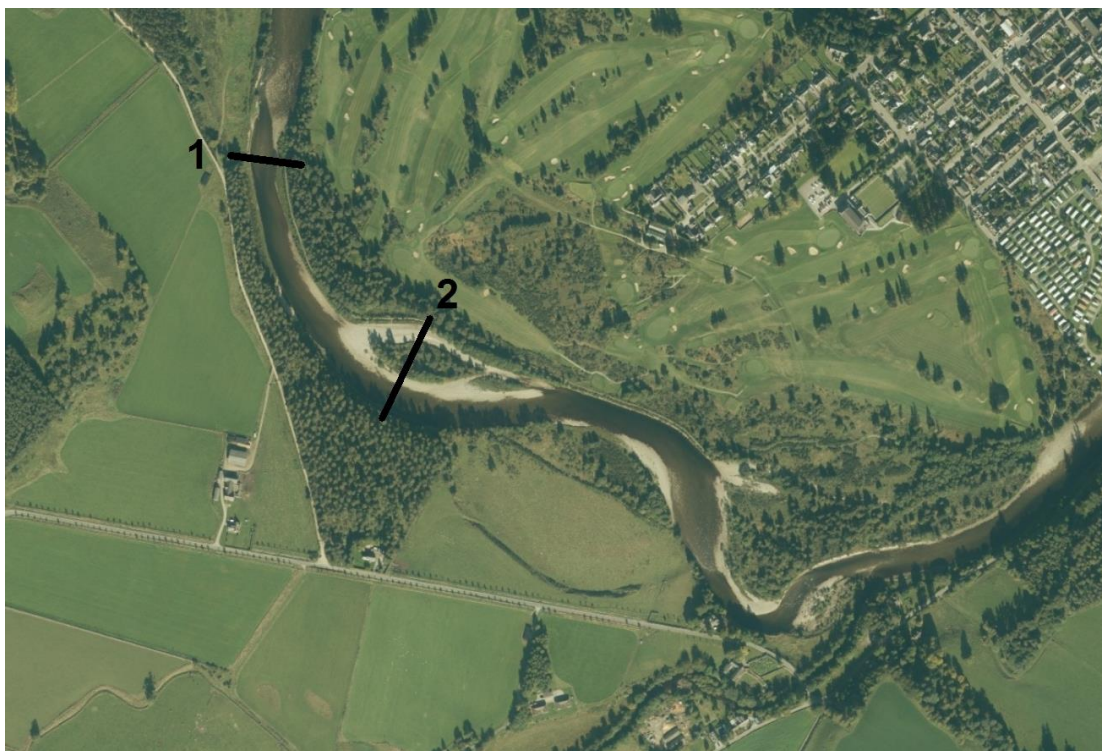
**Figure 56: Aerial image of Red Brae area showing location of cross-sections.**
